# Report:

## Testing: Digital automatic couplers

Climate chamber tests

DAC document: 60226-05-DAK-Phase I - Climate chamber tests

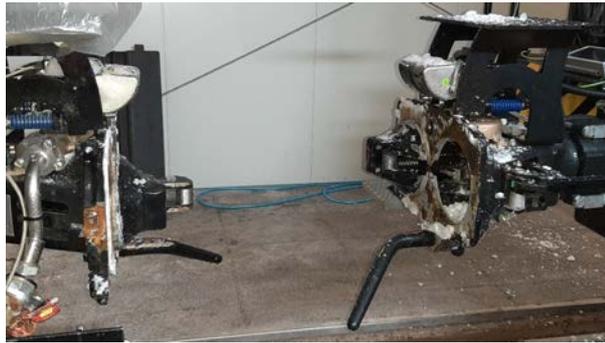
Date	Tests	Comments
16.02.2021	-5° C ... 0° C, wet snow	<ul style="list-style-type: none"> <li>Couplers in coupled state on one side despite unsuccessful mechanical coupling → Coupler had to be reset</li> <li>Display of coupling status partly undefined</li> <li>The wagon was pulled along despite the display showing that the coupler was uncoupled</li> </ul>

Fig. 8: The left DAC is in the coupled position despite the unsuccessful mechanical coupling procedure (photo 16.02.2021)

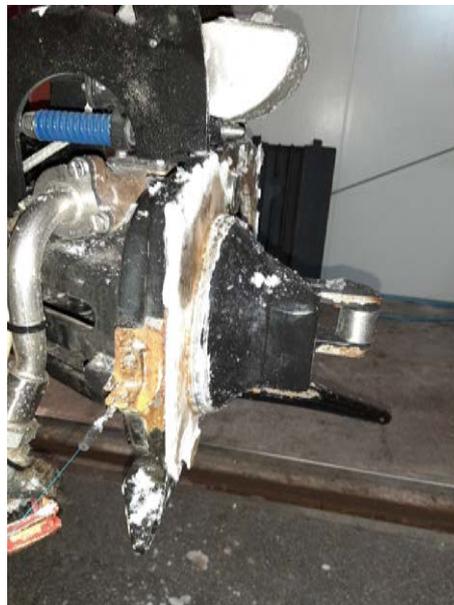
Fig. 9: Close-up of a DAC in coupled state after an unsuccessful mechanical coupling procedure. Highly compressed snow is visible on the face of the coupler (photo 16.02.2021)

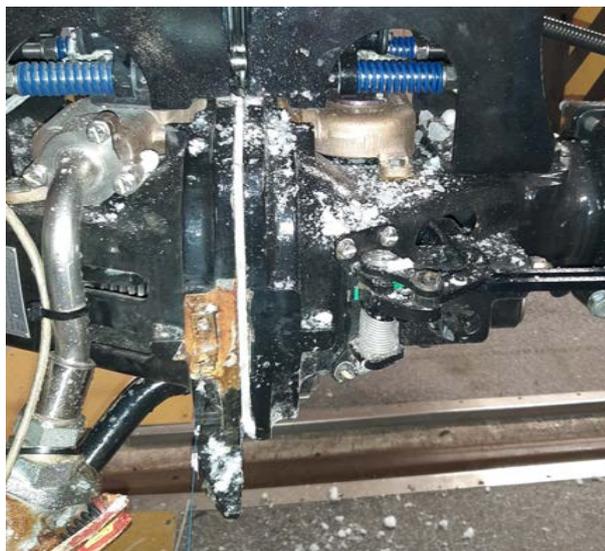
Fig. 10: Attempt to couple by pressing on both sides. DACs do not couple (indicator lines). A layer of snow is clearly visible between both the coupler heads (photo 16.02.2021)

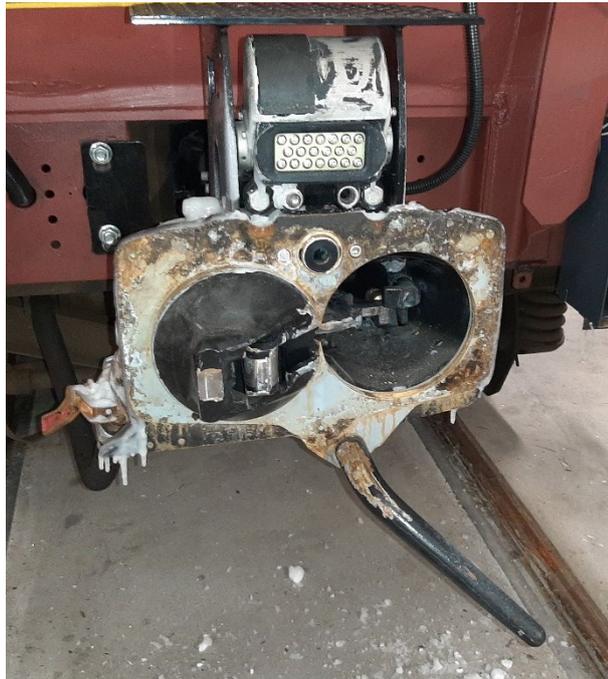
Fig. 11: E-coupler cover remained open after uncoupling (photo 18.02.2021)

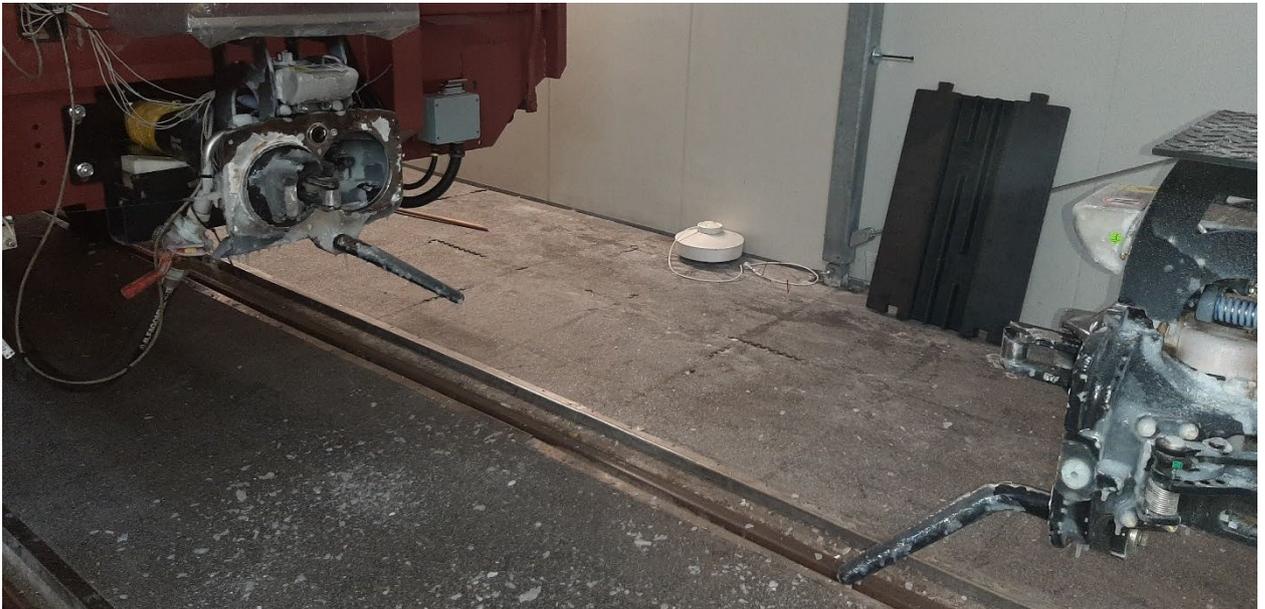
17.02.2021	-10° C, dry	<ul style="list-style-type: none"> <li>Uncoupling incomplete on one occasion → Air valve remained open</li> </ul>
18.02.2021 19.02.2021	-10° C, 3 to 5 mm ice	<ul style="list-style-type: none"> <li>No mechanical coupling</li> <li>Cover of e-coupler remained open after uncoupling</li> <li>Display of coupling status partly undefined</li> <li>Couplers in coupled state on both sides despite unsuccessful mechanical coupling → Couplers had to be reset</li> </ul>

Fig. 12: Both DACs are in the coupled position despite the unsuccessful mechanical coupling procedure (photo 18.02.2021)

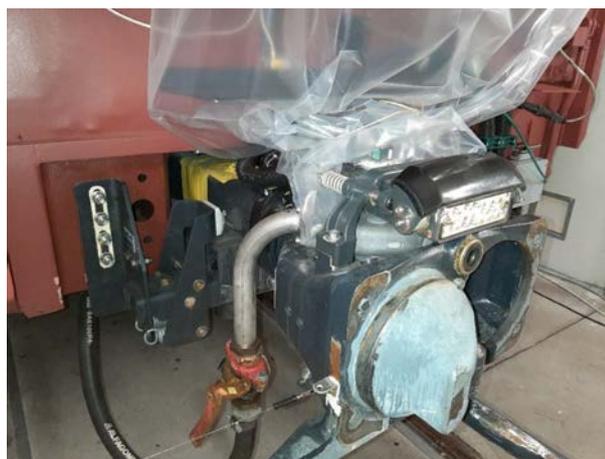
Date	Tests	Comments
12.01.2021	-10° C, dry	<ul style="list-style-type: none"> <li>Cover of e-coupler remained open after uncoupling (rubber seal had become hard)</li> </ul>

Fig. 13: Cover of e-coupler remained open after uncoupling (photo 12.01.2021)

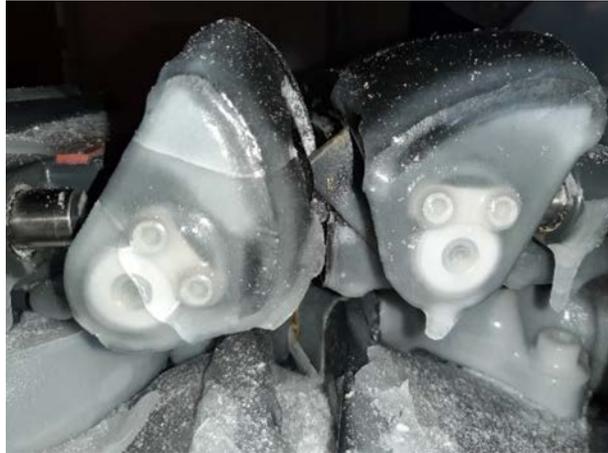
13.01.2021 14.01.2021 15.01.2021	-10° C, 3 to 5 mm ice	<ul style="list-style-type: none"> <li>Cover of e-coupler remained open after uncoupling</li> <li>Uncoupling often incomplete → Air valve remained open</li> <li>Cover of e-coupler became wedged during coupling</li> <li>Air valve of Z-wagon leaking</li> </ul>

Fig. 14: Jammed e-coupling cover during coupling (photo 13.01.2021)

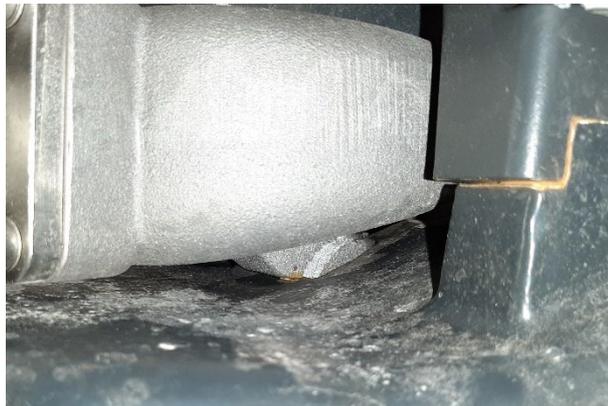
28.01.2021	+40° C, dry air	<ul style="list-style-type: none"> <li>Air valve housing on Z-wagon broken</li> </ul>
03.02.2021	+45° C, dry air	-
04.02.2021	+45° C, 90 % humidity	<ul style="list-style-type: none"> <li>Uncoupling incomplete → Air valve remained open</li> <li>Air valve housing on H-wagon (Z-side) broken</li> </ul>

Fig. 15: Broken air valve housing (photo 28.01.2021)

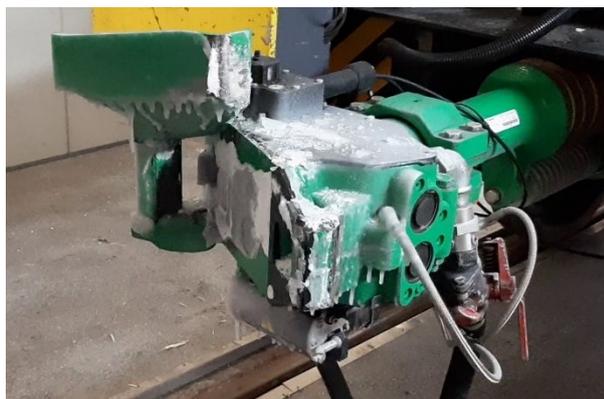
06.05.2021 07.05.2021	-10° C, 3 to 5 mm ice	<ul style="list-style-type: none"> <li>Incomplete coupling, display remained on “3”, nevertheless force was required to separate the wagons</li> </ul>

Fig. 16: Compressed layer of ice on the coupler head after failed mechanical coupling procedure (photo 06.05.2021)

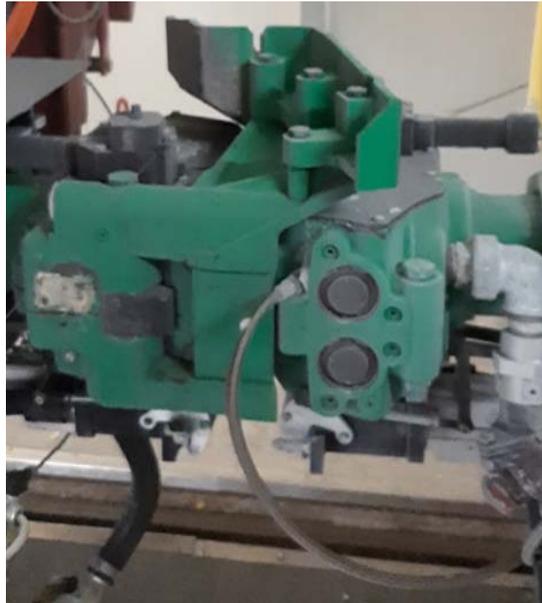
10.05.2021	-25° C, dry	<ul style="list-style-type: none"> <li>Problems with pneumatic coupling E- and H-wagon</li> <li>Force required to separate the wagons: E-side 6 to 13 kN, Z-side 16 to 25 kN</li> </ul>

Fig. 17: Incomplete coupling, left coupler head shows “3” in the coupler display, right coupler head shows “1” (not visible in photo, photo 10.05.2021)
